C地点調査の様子

C地点毛萱仮設焼却炉のガンマ線イメージング画像V5

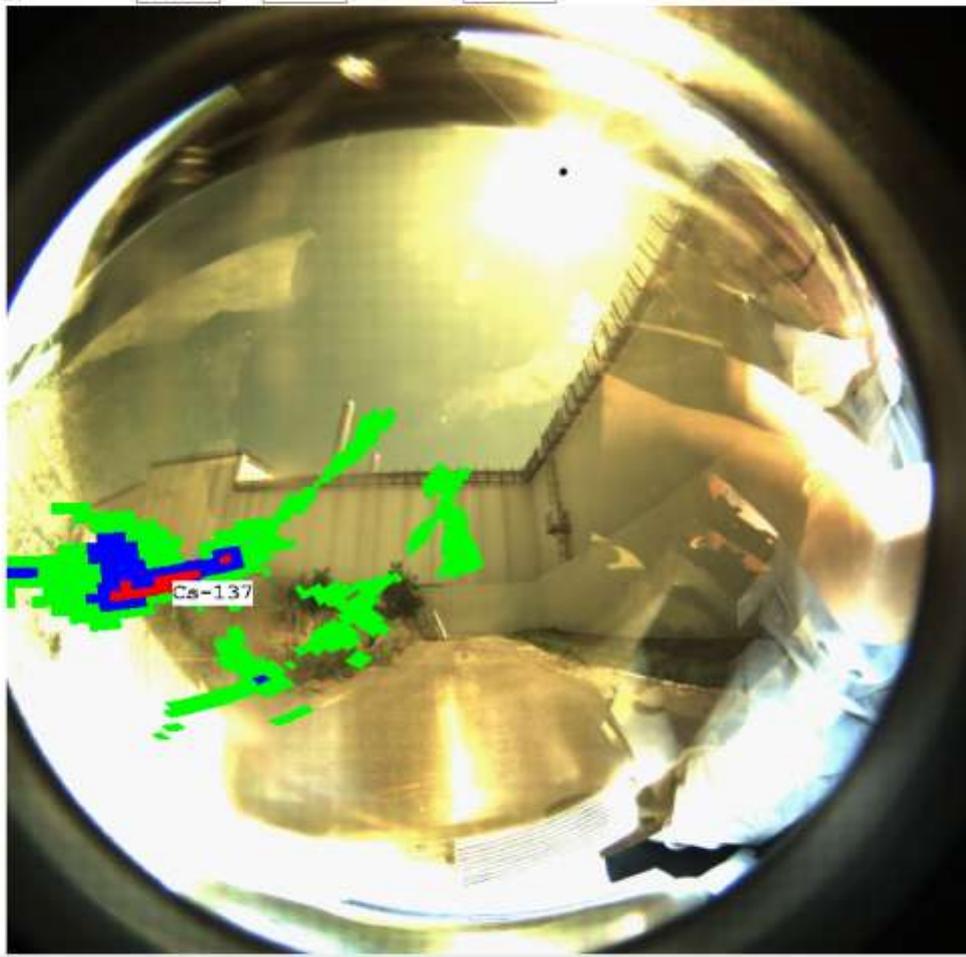
C地点毛萱仮設焼却炉のガンマ線イメージング画像V6

- 仮設焼却炉北側から全景撮影V5では建屋フェンス下部にやや強い場所が見られた。これは建屋内からのものか、手前フェンス付近からのものか識別できない。
- V5のカメラ近傍の下部のやや強い場所は空き地の草むらからの影響と考えられる。
- 煙突直下V6では煙突下右側に最も強い場所があり、そこから煙突方向にやや強い場所が細長く伸びている。最も強い場所は建屋内部からのものか、手前の草むらからのものか識別できない。煙突方向に長く伸びた部分は煙突からの影響の可能性も考えられるが断定できない。
- 焼却炉正面からの撮影V7では、手前下部に帯状にやや強い場所がある。カメラ前方下部は工事用鉄板が敷いてある。このことから、これはカメラ後方の駐車場からのコンプトンと考えられる。
- V7画像の煙突下部のやや強い場所は建物内からのものか、手前の草むらからの影響か識別できない。
